PARTNERING to save VALLEY CREEK

By Betsie Blumberg and Brian Lambert

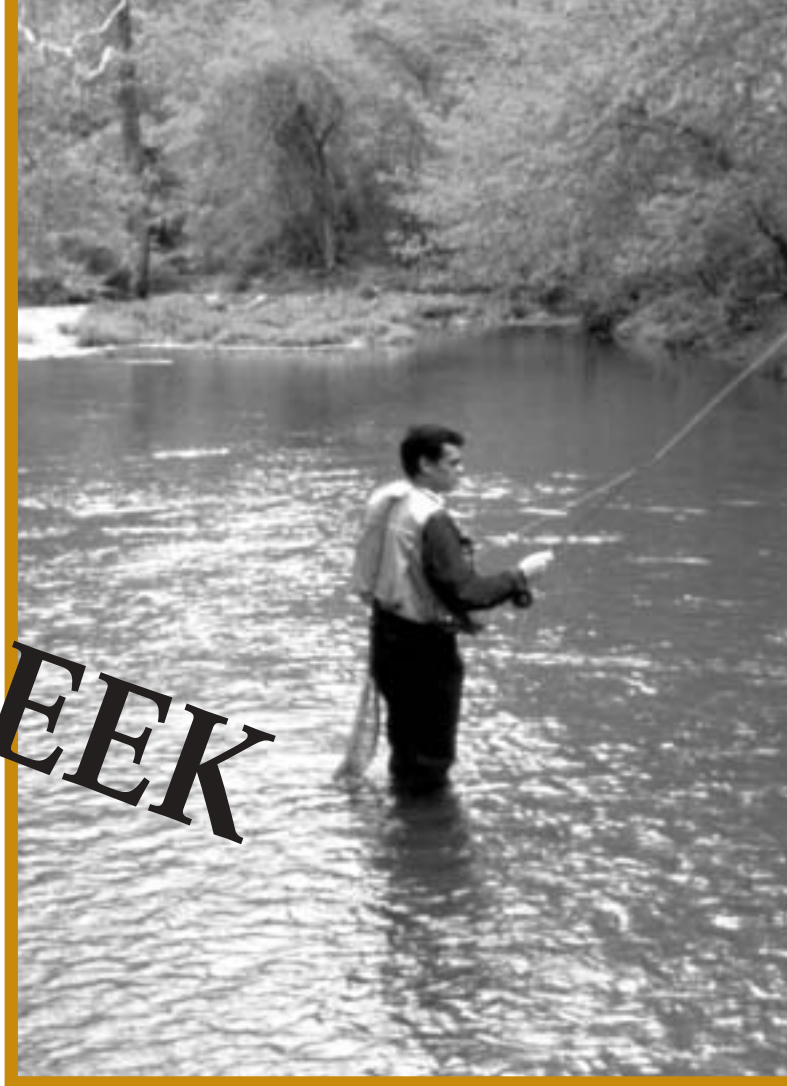
Figure 1. Located north of Philadelphia and flowing through Valley Forge National Historical Park, Valley Creek is an important recreational resource for area residents. In 1993 the creek was officially designated as having “exceptional value,” an important management tool for protecting the creek’s water quality.

Valley Creek is an outstanding trout stream in Pennsylvania (fig. 1). Twelve miles long, the creek runs through five townships just north of Philadelphia and flows through Valley Forge National Historical Park where it empties into the Schuylkill River. This limestone stream, remarkable for its beauty, is an important recreational resource for the five-county area around Philadelphia.

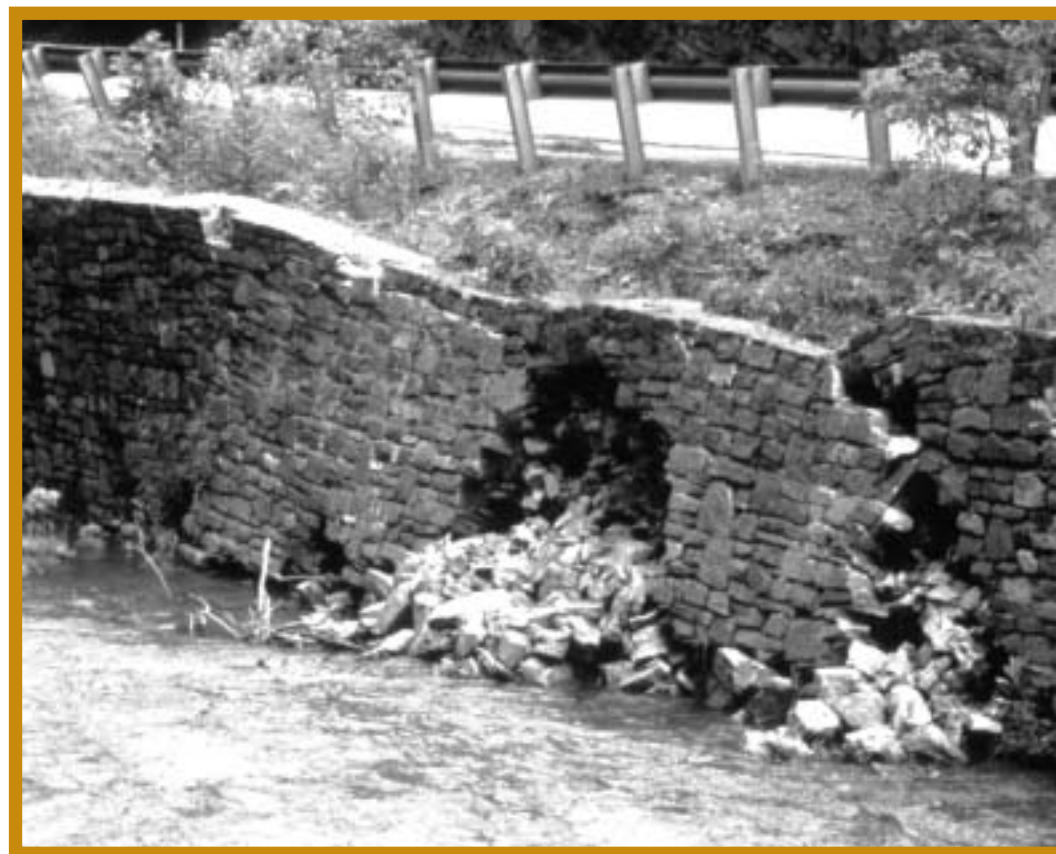
Figure 2. Development in the area of Valley Creek has led to increased erosion of the stream bank, which threatens the collapse of Pennsylvania Route 252. In addition to traditional engineering, the partnership to restore Valley Creek is using soil, rocks, and plants in bioengineering solutions to stabilize stream banks.

The national historical park and PennDOT have a common problem. Valley Creek is eroding its banks so severely that Route 252, which runs along its east bank, is in danger of collapsing. In fact, a 200-foot (67-meter) portion of it did collapse in 1990. Beneath the road is a sewer main that carries 8 million gallons of sewage per day. A break in the sewer would be disastrous, severely polluting the creek, killing stream life, and further damaging habitat. On the west bank, the Valley Creek hiking trail has been damaged in the past and is constantly in similar danger.

The restoration project combines conventional hard engineering with bioengineering, a "soft" approach that uses rock, soil, and plants. Different treatments will be used, appropriate to the characteristics of the three stream sections to be repaired. Bioengineering techniques will stabilize one section where coconut fiber rolls will be installed at the toe, and trees and shrubs will be planted on the upper parts of the stream bank. The second section of the stream bank is an outside bend, where erosive forces are greatest and will be protected by large riprap rock.
